SPECIAL REPORT

Development works of the H-IIA rocket engine in Mitsubishi Heavy Industries, Nagoya Guidance & Propulsion System (MHI-MEIYU)

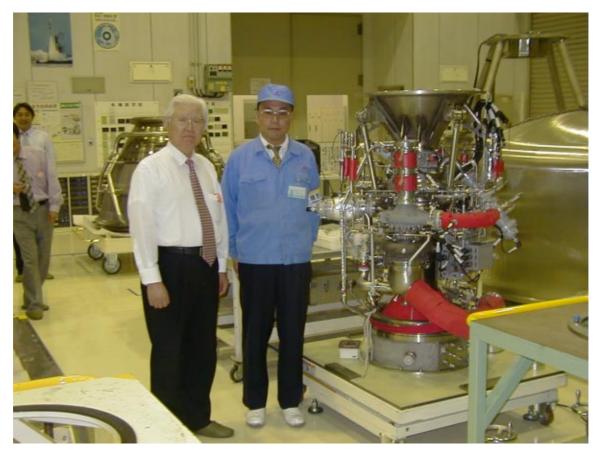
No.4: The LE-5B engine for the HII-A rocket number 3

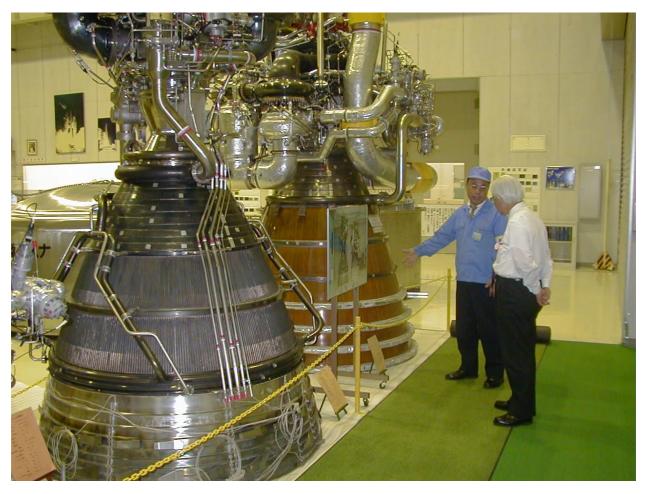
No.6: Compares of 6: LE-7A (the left) and LE-7 engine explained by Mr. Matsuyama

The data that gave settle the item that collects wisdom idea from the experience of the development, production, inspection of LE-7 and should reflect to the development work of LE-7A became of an enormous amount. In many king files, it became 1 meter and more. For example, to use the 3D CAD, it simplifies the adjustable configuration of thermal/stress design and makes higher reliability.

For the production level, the key was to make it easy as much as possible, which means decrease the number of the welding place.

As a result, it was decreased the welding place where there were about 260 places in LE-7 to 60 places in LE-7A.

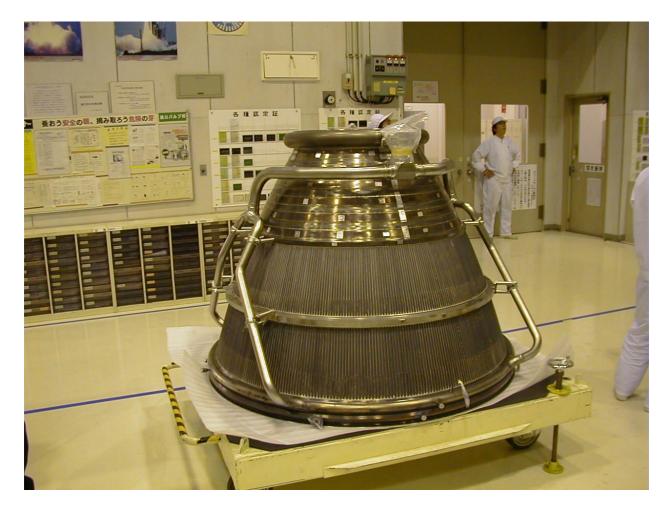
No. 8-1: The nozzle skirt of the LE-7A engine

Being thinking the more improvement, that is consists in the more modification for the 1st stage engine (LE-7A), Mr. Matsuyama said. The modification is to reinforce the design of an engine nozzle skirt. It is intended that reinforcement and improve to the thrust 112 tons of rating thrusts by making a long skirt aiming at the H-IIA Rocket No.4, in which now the No. 1 machine, although it is the mini- skirt (nozzle skirt), that is aggregate of the numerous pipe which has the wall of 0.5 mm and 109.5 tons with the rating thrust.

I feel realistically that there is most difficulty development job that the technology for even the nozzle skirt that is seen simply in terms of the appearance materializes the structure that bears the 110 tons of thruster with difference of temperature in between minus 250 degrees Celsius and 3,000 degrees Celsius such as temperature designs, cooling fluids, air tightness, strength is not able to speak thoroughly in the mouth.

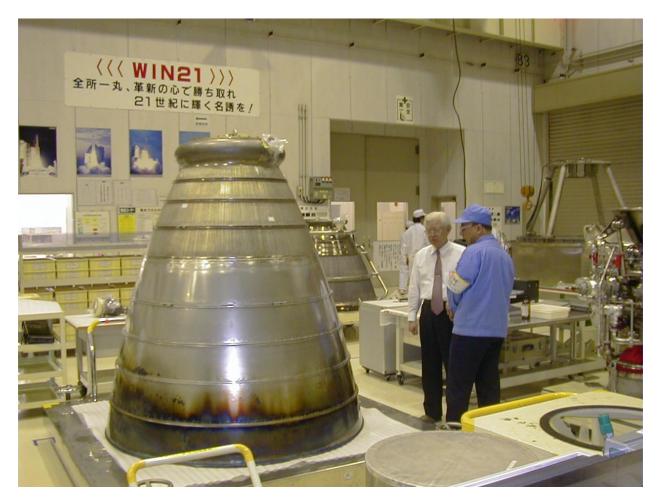
No. 8-2: The nozzle skirt of the LE-5B engine

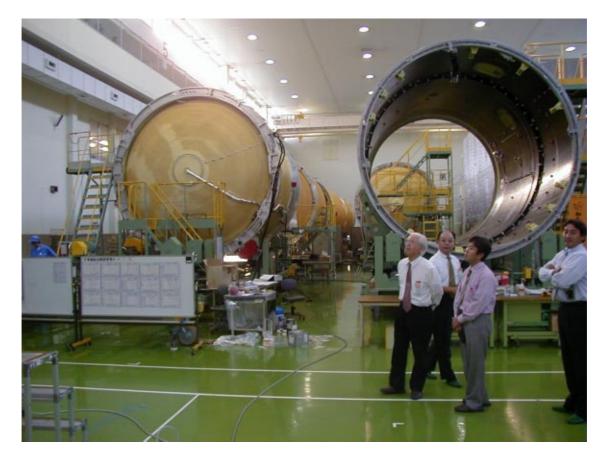
No. 10: HII-A rocket assembling with big supply

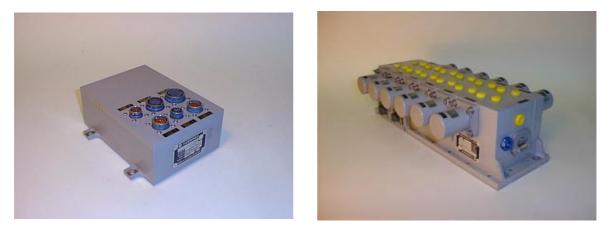
No. 11: Valve control electronics

There are controller and numeric package as an electronics function that is controlling the valve in the rocket engine that is composed of a precise machine complex structure.

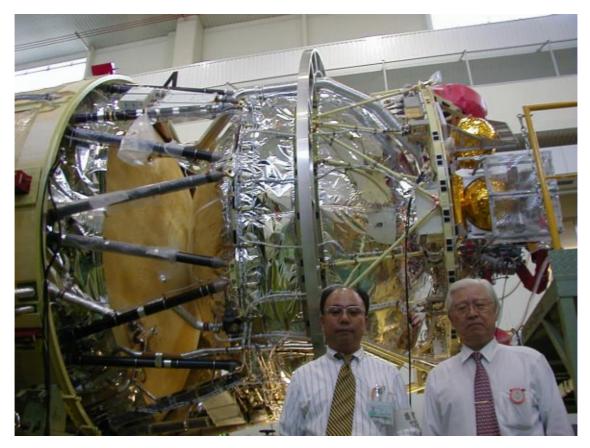
No. 13: In front of H-IIA rocket 2 stage assembling
